magicolor[®] 330

Service Manual

November 2000
1750049-001B

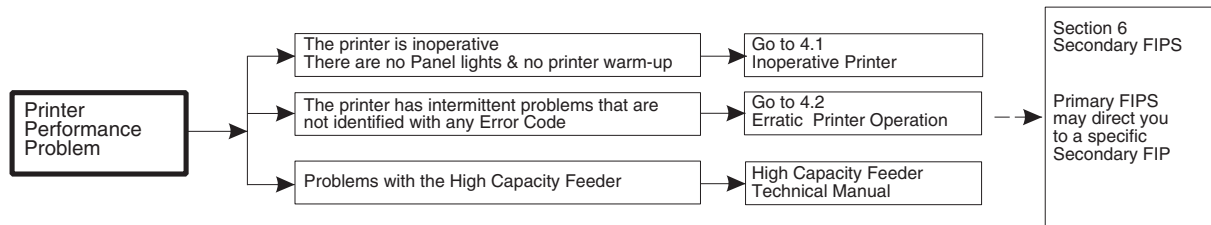
Printer Performance Problem Flow Chart

The FIP Flowchart should have directed you to this section. Start at your problem box, then follow the arrow leading to the individual FIP that corresponds to that problem. Primary FIPs may direct you to a Secondary FIP. In the Performance Problems Flowchart, the relationship between Primary and Secondary FIPs is represented by dotted lines

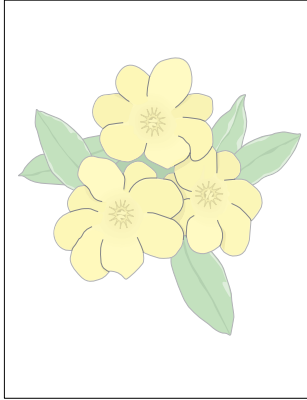
RS500X

5.1 - Light (Undertoned) Prints

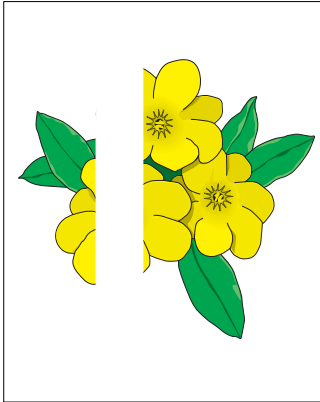
5.4 - Vertical Band Deletions

There are areas of the image that are extremely light or are missing entirely. These missing areas form wide bands that run vertically along the page in the direction of paper travel. **THE PRINTER DISPLAYS NO ERROR MESSAGE.**

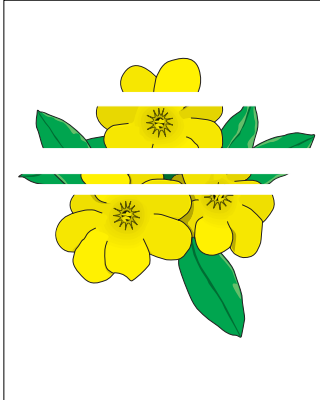
RS504X

5.5 - Horizontal Band Deletions

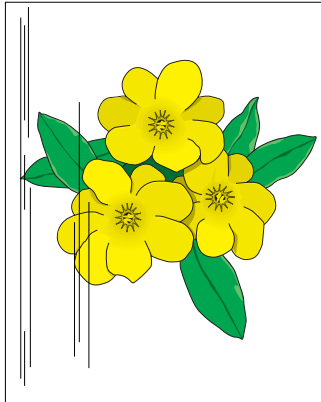
RS506X

5.6 - Vertical Streaks

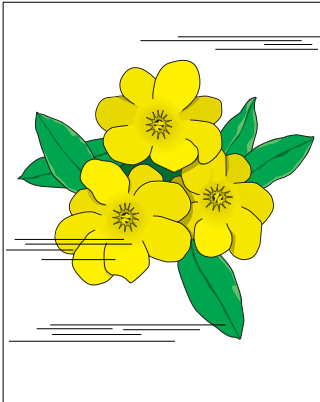
RS507X

5.7 - Horizontal Streaks

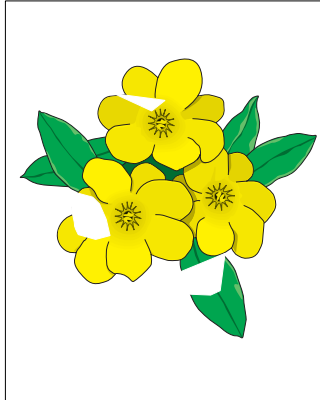
RS508X

5.8 - Spot Deletions

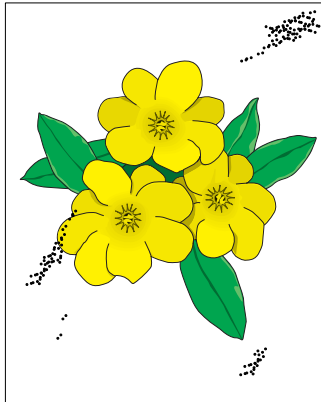
RS509X

5.9 - Spots

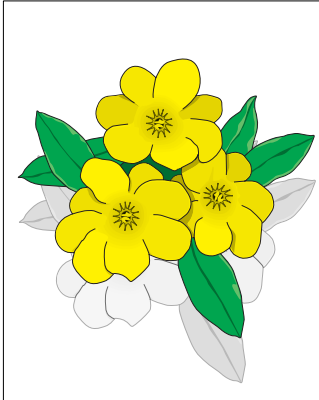
RS510X

5.10 - Residual Image or Ghosting

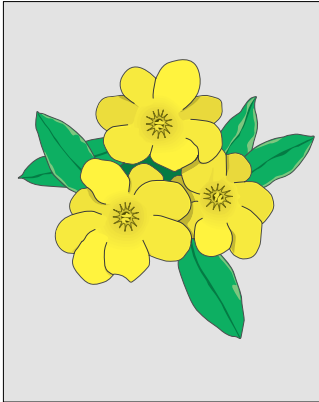
RS511X

5.11 - Background

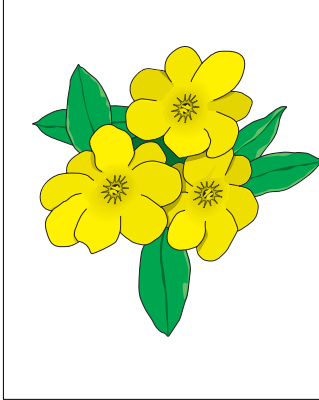
RS512X

5.13 - Skewed Image

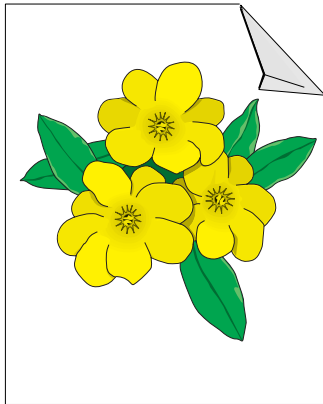
RS513X

5.14 - Damaged Prints

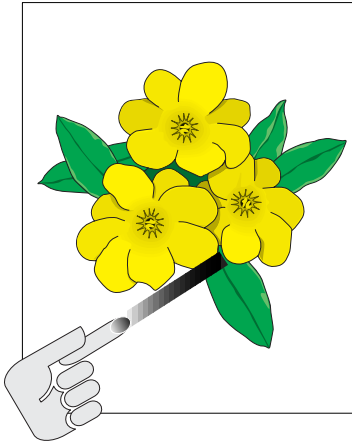
RS514X

5.15 - Unfused Image or Image Easily Rubs Off of Page

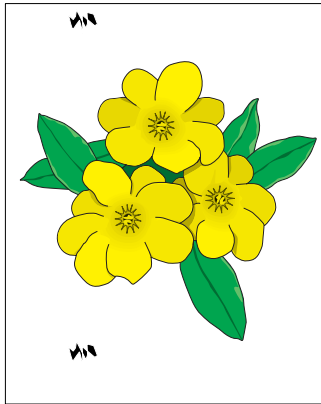
RS519X

5.16 - A Repetitive Mark Appears on Each Print

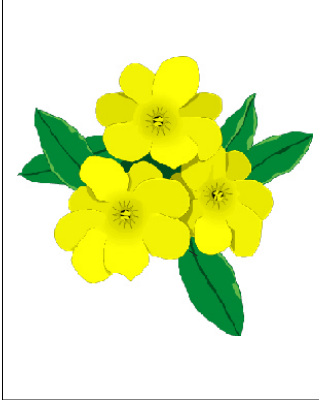
RS520X

5.17 - The Printed Image is Mottled

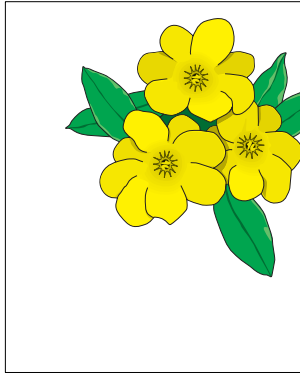
RS515X

5.18 - Image Not Registered Correctly on the Page

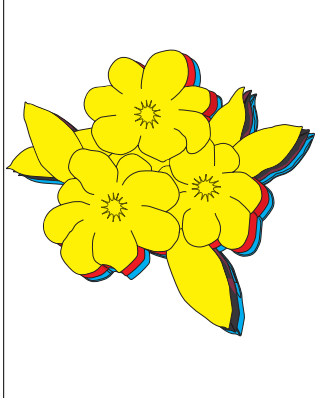
RS516X

5.19 - Color Layers are not Registered Correctly

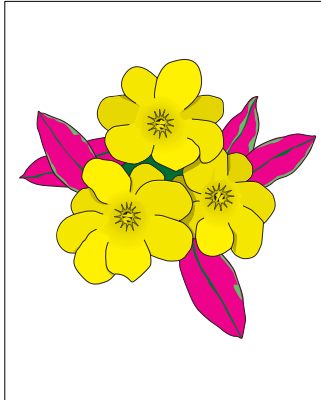
RS517X

5.20 - Color Representation Not Correct

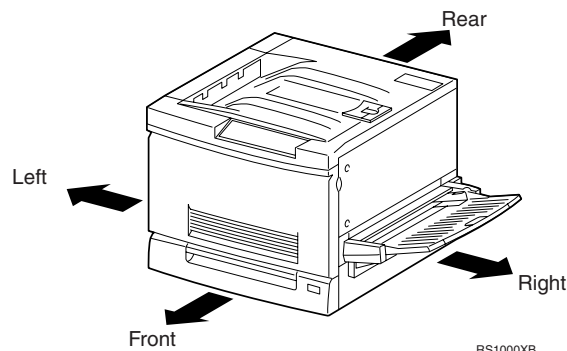
RS1000XB

- Locations, such as R or right, given in the RRP's assume you are facing the printer console panel.
- The notation "rear" of a component, in place or removed, refers to the side of the component that is, when installed, facing the rear of the print engine.

- The notation "front" of a component refers to the side of the component that is, if installed, facing the front of the print engine.
- The notation "(RRP X.Y)" in a RRP step, directs you to another RRP for information on how to perform a related or pre-requisite procedure.
- The notation "(Figure x)" points to the illustration that corresponds to the RRP you are performing.
- The notation "(PLX)" indicates that this component is listed in the PLX parts list.
- Arrows in an illustration show direction of movement when removing a component.

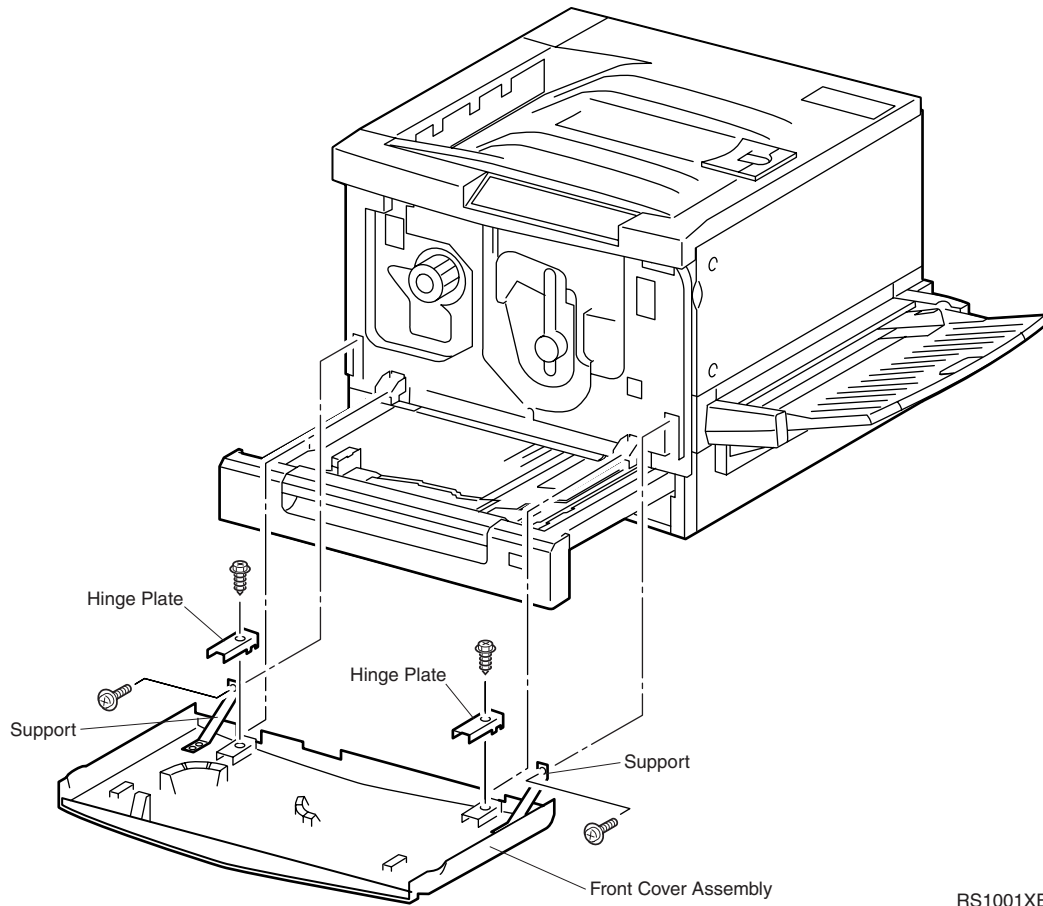
RS1001XB

RRP 9.1 Front Cover Assembly (PL1.1.1)

10. Close and open the Front Cover Assembly, making sure the Cover moves freely and without binding.
11. Slide Tray 1 back into the printer.

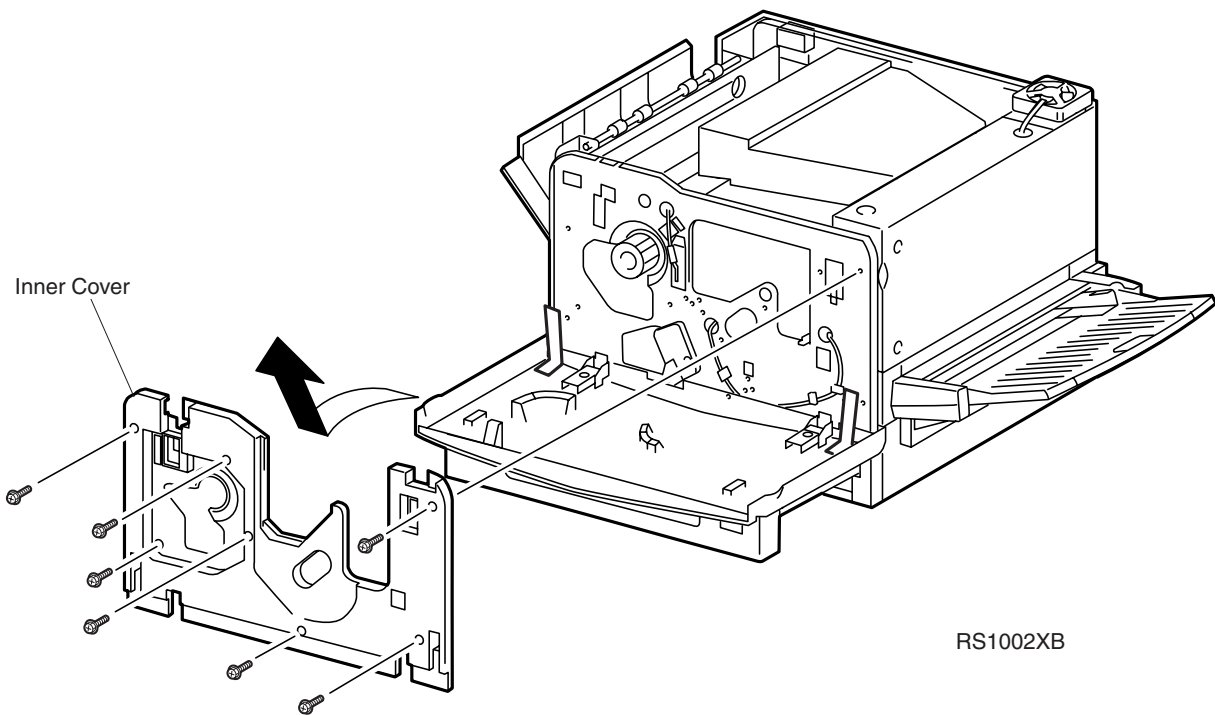
RS1002XB

RRP 9.2 Inner Cover Assembly (PL1.1.10)

1. Position the Inner Cover against the printer frame, making sure the top of the Cover is under the lip of the Top Cover.
2. Use seven screws to secure the Inner Cover to the printer frame.
3. Reinstall the Tension Lever (RRP 9.72).
4. Reinstall the Xerographic Cartridge (RRP 9.48).
5. Reinstall the Front Cover Assembly (RRP 9.1).

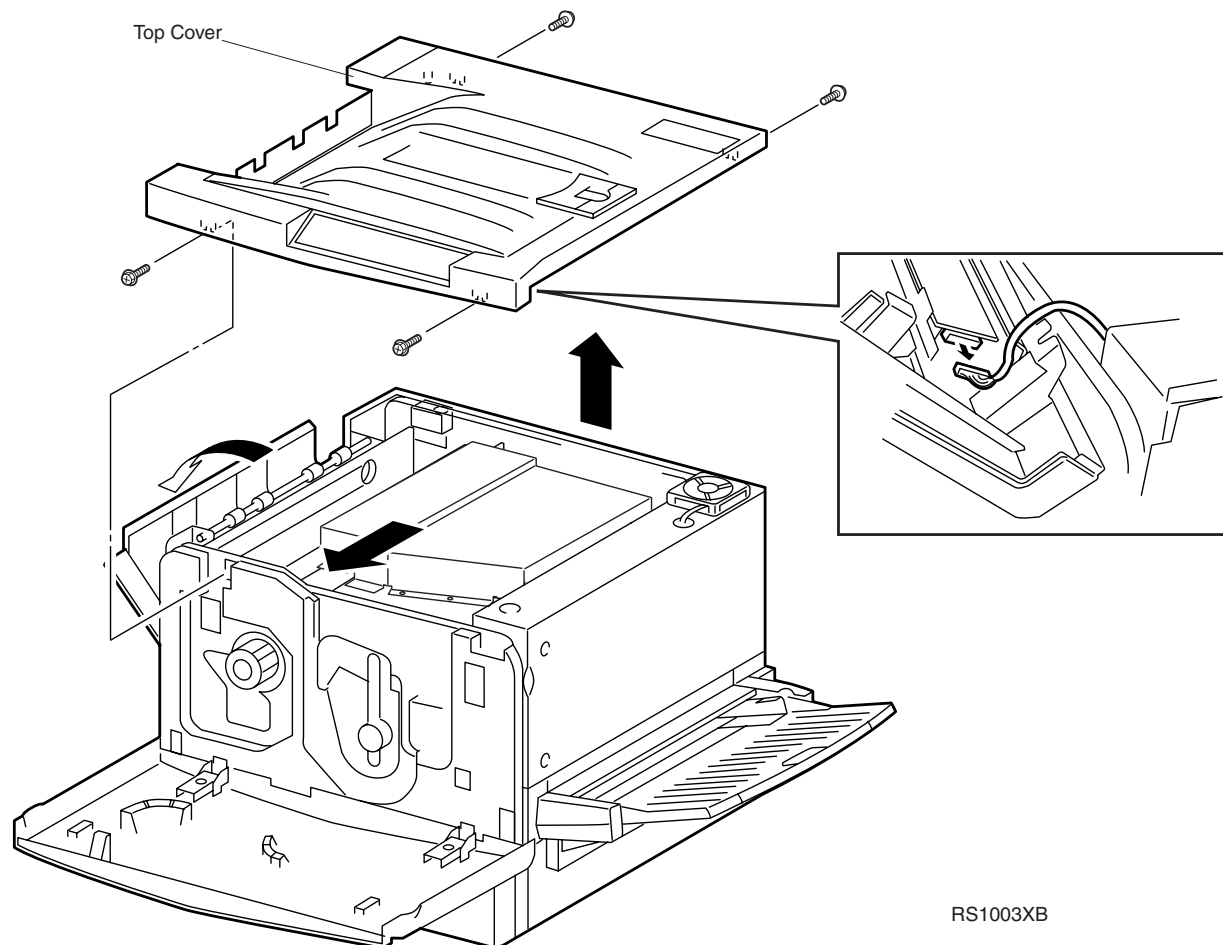
RS1003XB

RRP 9.3 Top Cover Assembly (PL1.1.20)

1. Remove the Rear Cover (RRP 9.4).
2. Open the Front Cover.
3. Open the Upper Exit Cover.
4. Position the Top Cover as shown in the figure.
5. Push the Full Stack Sensor actuator out of the way.
6. Slide the front of the Top Cover onto the front of the printer frame.
7. Reconnect P/J317 to the Operation Panel.
8. Reinstall the rear of the Top Cover onto the rear of the printer frame.
9. Reposition the Top Cover so the Exit Rolls fit through the cutouts in the left side of the Top Cover.
10. Reposition the Top Cover so the two screw holes at the rear of the Cover and the two holes at the front of the Cover line up with the screw holes in the printer frame.
11. Use two screws to secure the front of the Top Cover to the printer frame.
12. Close the Upper Exit Cover.
13. Close the Front Cover.
14. Reinstall the Rear Cover (RRP 9.4).

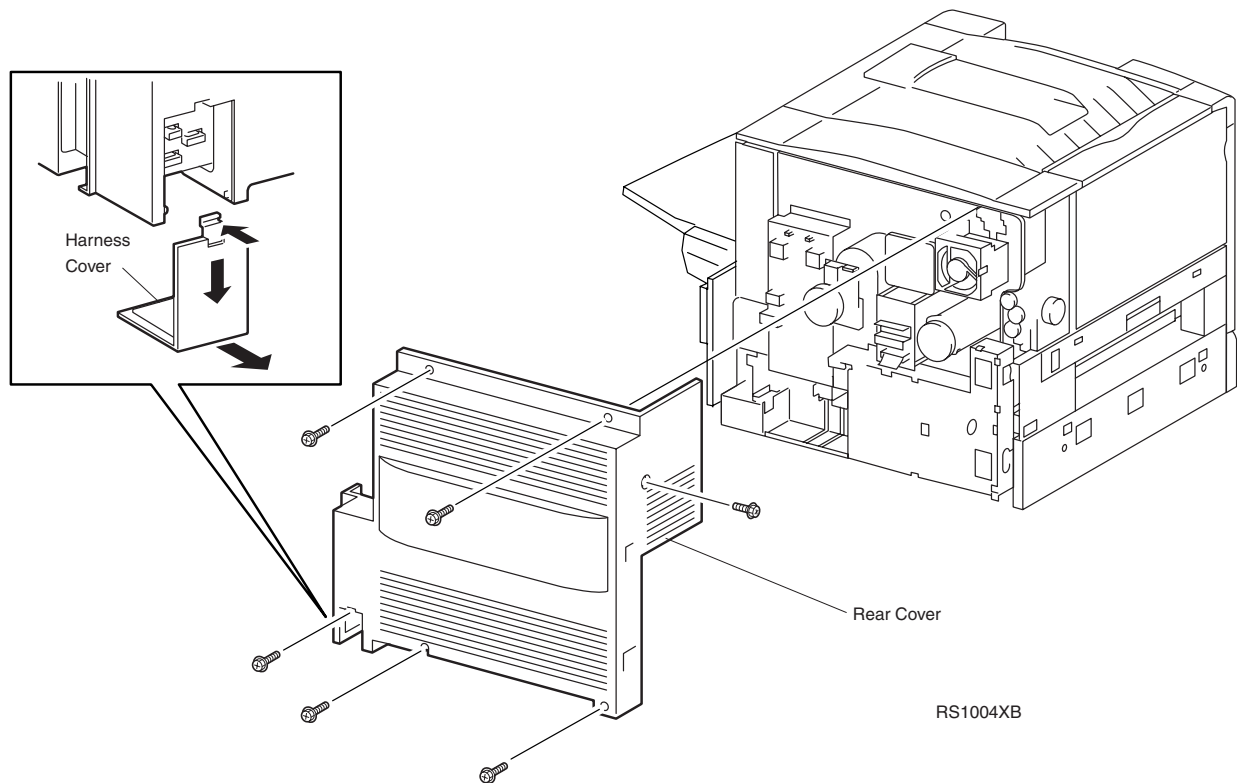
RS1004XB

RRP 9.4 Rear Cover (PL1.1.31)

1. Open the Upper Exit Cover.
2. Slide the Main Paper Handling Assembly a few inches out of the printer.
3. Reinstall the Rear Cover onto the printer frame.
4. Reposition the Cover so the six screw holes in the Cover line up with the five screw holes in the printer frame.
5. Use five screws to secure the Rear Cover to the printer frame.
6. Slide the Main Paper Handling Assembly into the printer.
7. Reinstall the Harness Cover.
8. Close the Upper Exit Cover.

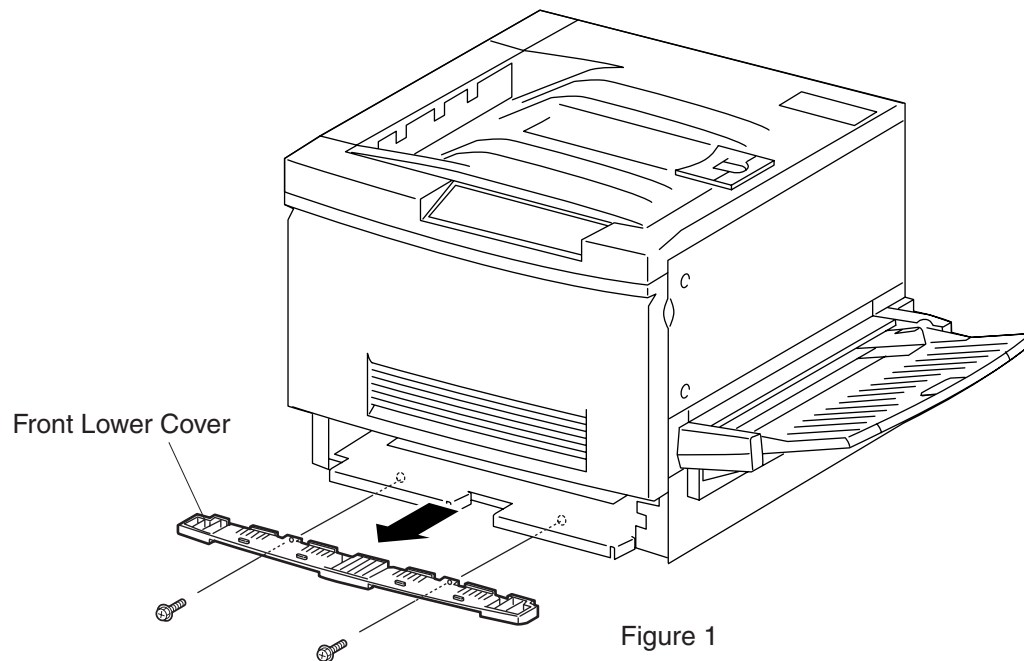
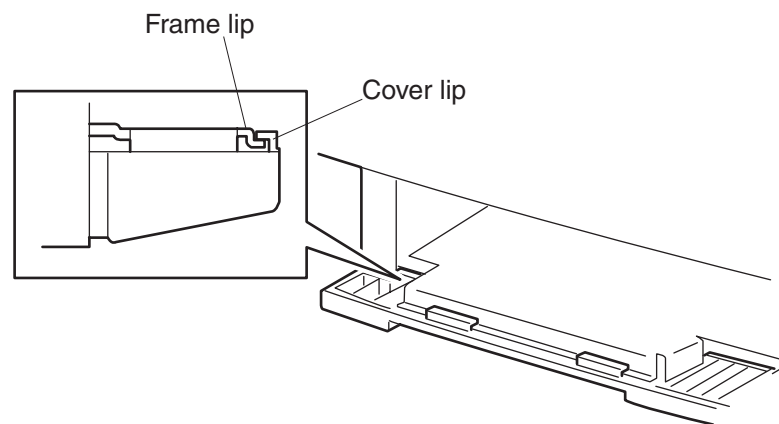
RS1051XB

RRP 9.5 Front Lower Cover (PL1.1.5)

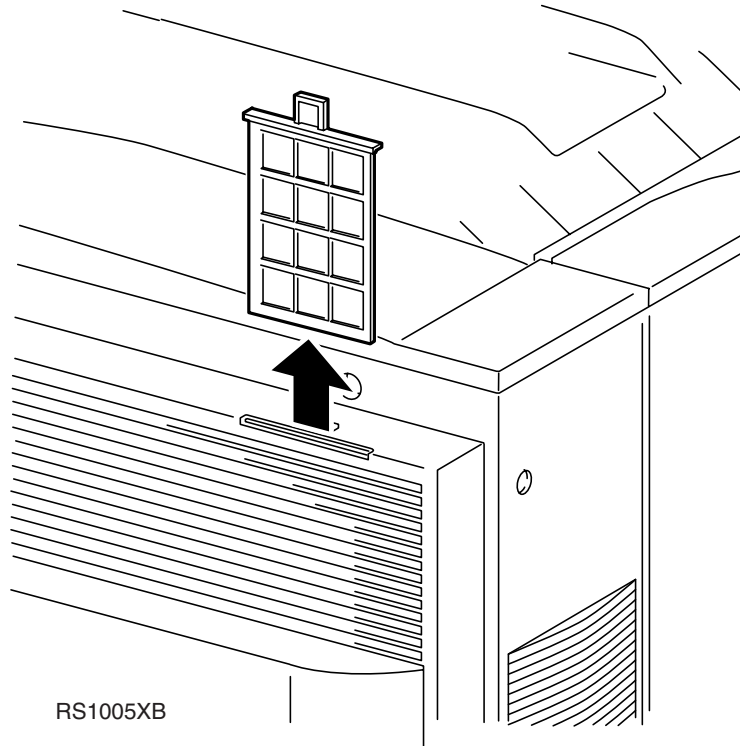
RRP 9.6 Filter Assembly (PL1.1.32)

1. Position the Filter at the opening of the slot in the Rear Cover, making sure the release tab at the top of the Filter faces the latch on the Rear Cover.
2. Press the Filter release tab as you slide the Filter into the slot.
3. When the Filter bottoms out, release the tab making sure the tab hooks into the latch on the Rear Cover.

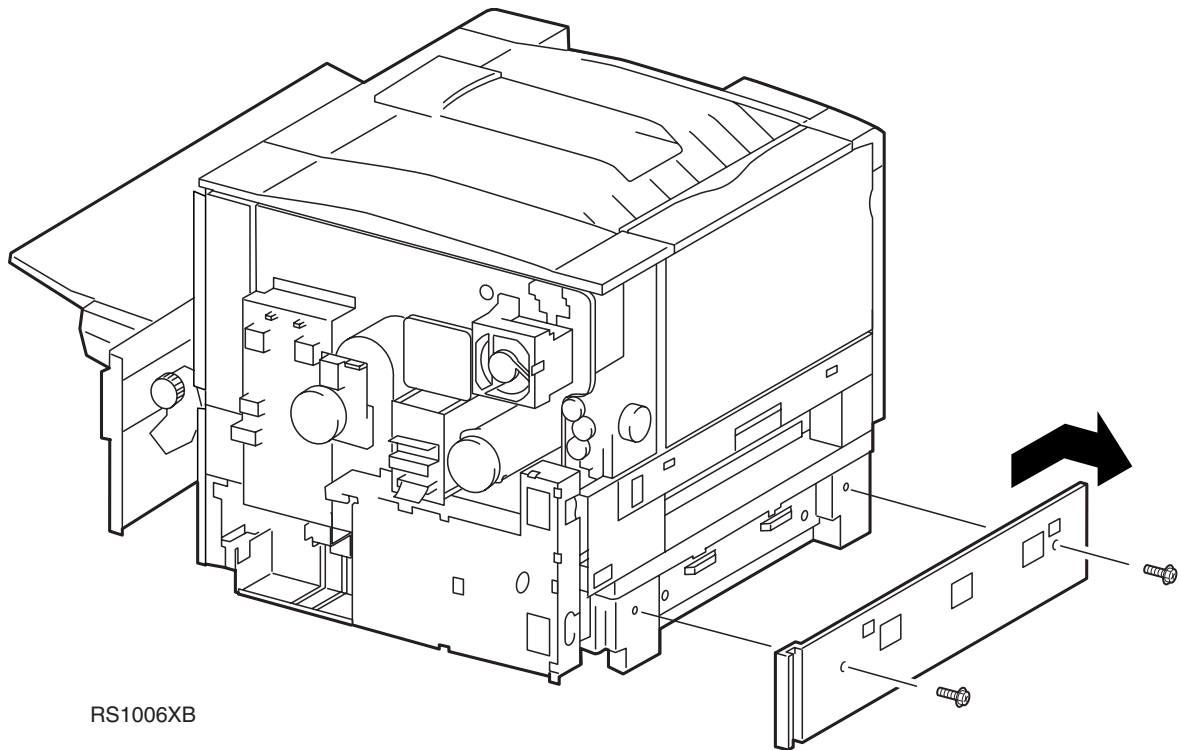
RRP 9.7 Left Lower Cover (PL1.1.40)

1. Position the Left Lower Cover against the printer frame.
2. Reposition the Cover so the two screw holes in the Cover line up with the two screw holes in the printer frame.
3. Use two screws to secure the Left Lower Cover to the printer frame.
4. Slide the Fuser Assembly into the printer.

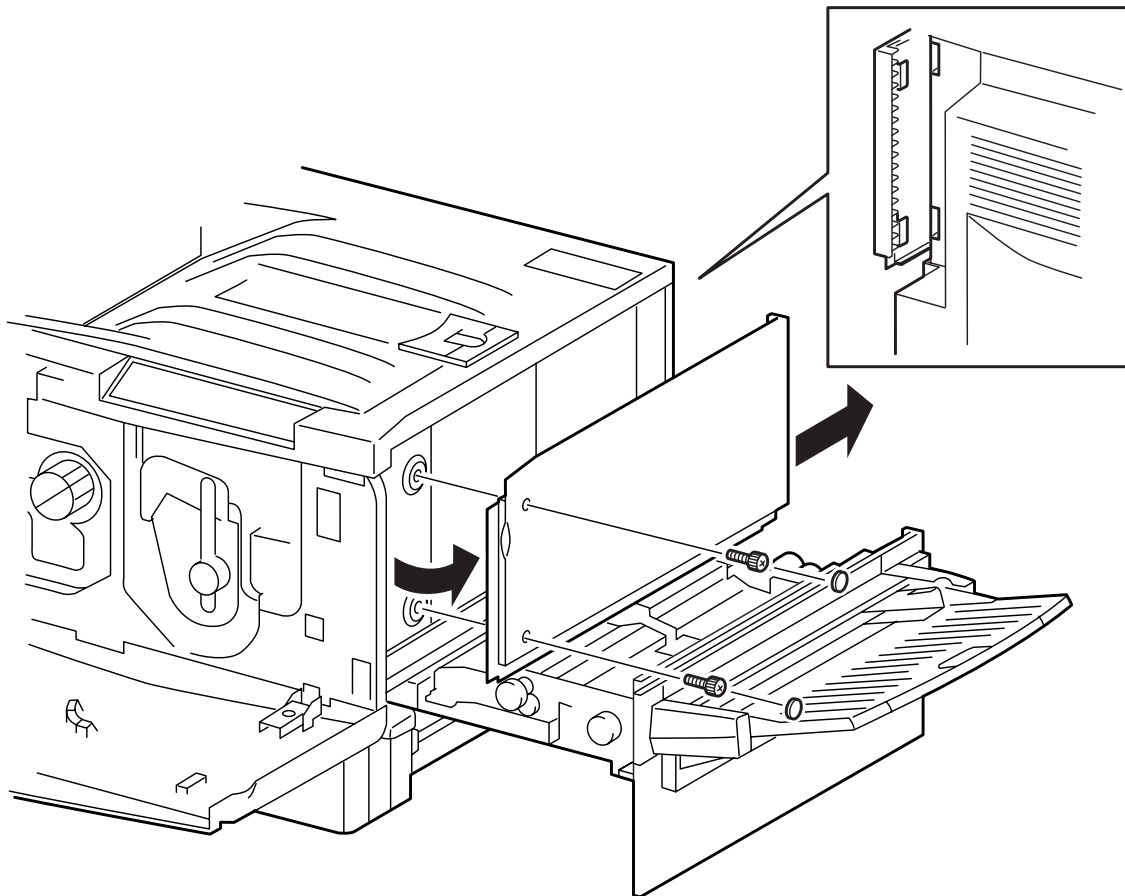
RRP 9.8 Right Cover Assembly (PL1.1.50)

1. Slide the Main Paper Handling Assembly a few inches out of the printer.
2. Open the Front Cover.
3. Insert the two metal tabs located at the rear of the Cover into the two slots in the printer frame.
4. Slide the Cover to the front of the printer.
5. Press the Cover against the printer frame, making sure the positioning tab located at the top front of the Cover fits into the hole in the printer frame.
6. Reposition the Cover so the two screw holes in the Cover line up with the two screw holes in the frame.
7. Use two screws to secure the Cover to the printer frame.
8. Reinstall the screw caps to cover the screw heads.
9. Close the Front Cover.
10. Slide the Main Paper Handling Assembly into the printer.

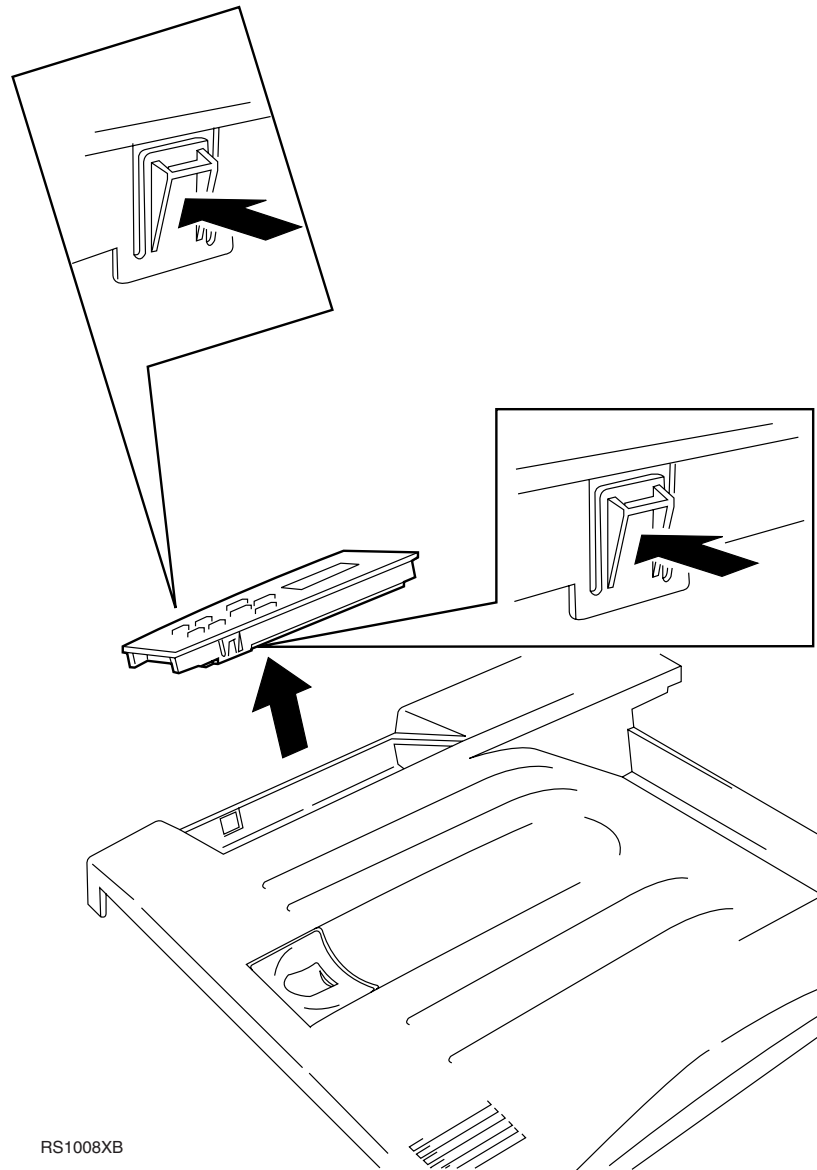
RRP 9.9 Operation Panel (PL1.1.60)

1. Position the Operation Panel as shown in the figure.
2. Press the Operation Panel into the opening in the Top Cover.
The Panel snaps into place.
3. Reconnect the Operation Panel P/J.
4. Reinstall the Top Cover Assembly (RRP 9.3).

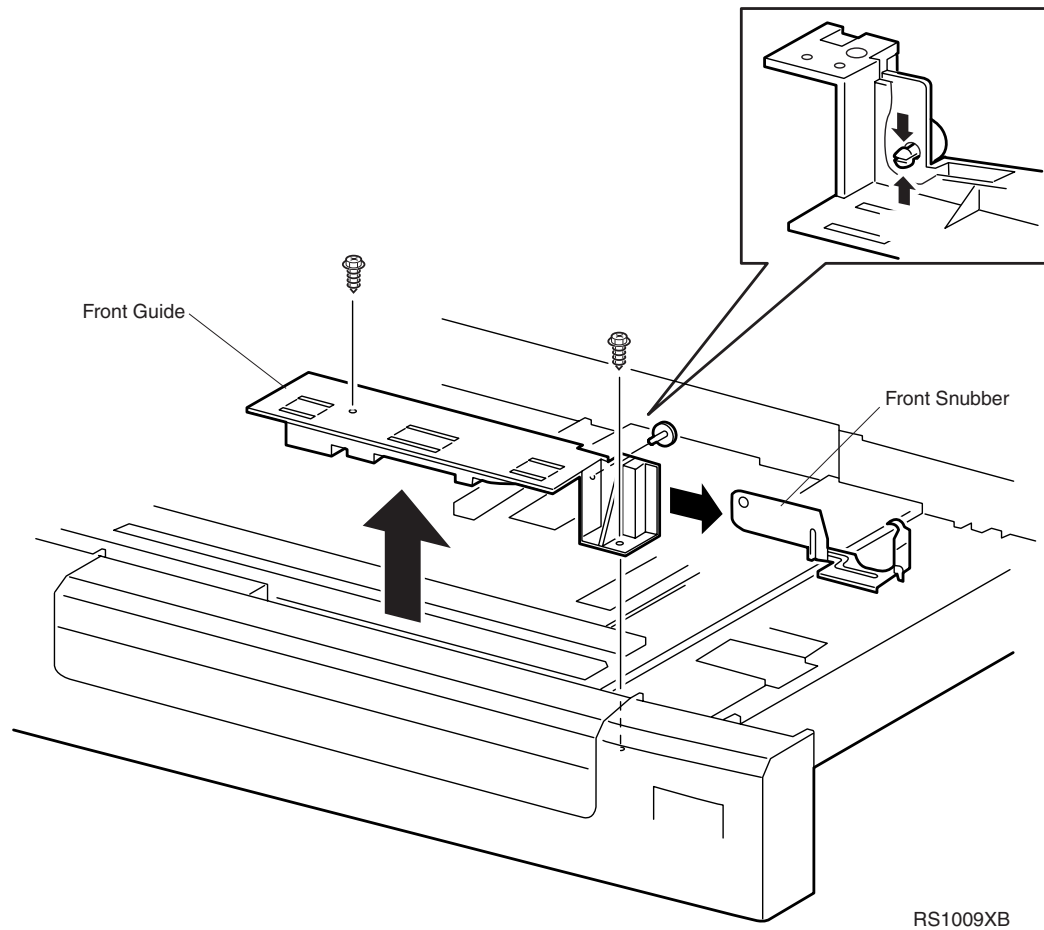
RRP 9.10 Front Snubber (PL2.2.9)

1. Position the Front Snubber against the Front Guide, making sure the hole in the Snubber lines up with the hole in the Guide.
2. Slide the through the hole in the Front Snubber and press firmly until the fastener locks into place.
3. Slide the Snubber under the Bottom Plate Assembly, and hook the Snubber Latch through the cutout in the side of the Tray.
4. Position the Front Guide so the tabs in the Tray fit through the cutouts in the Guide.
5. Reposition the Front Guide so the two screw holes in the Guide line up with the two screw holes in the Tray.
6. Use two screws to secure the Front Guide to the Tray.
7. Reinstall Tray 1 into the printer.

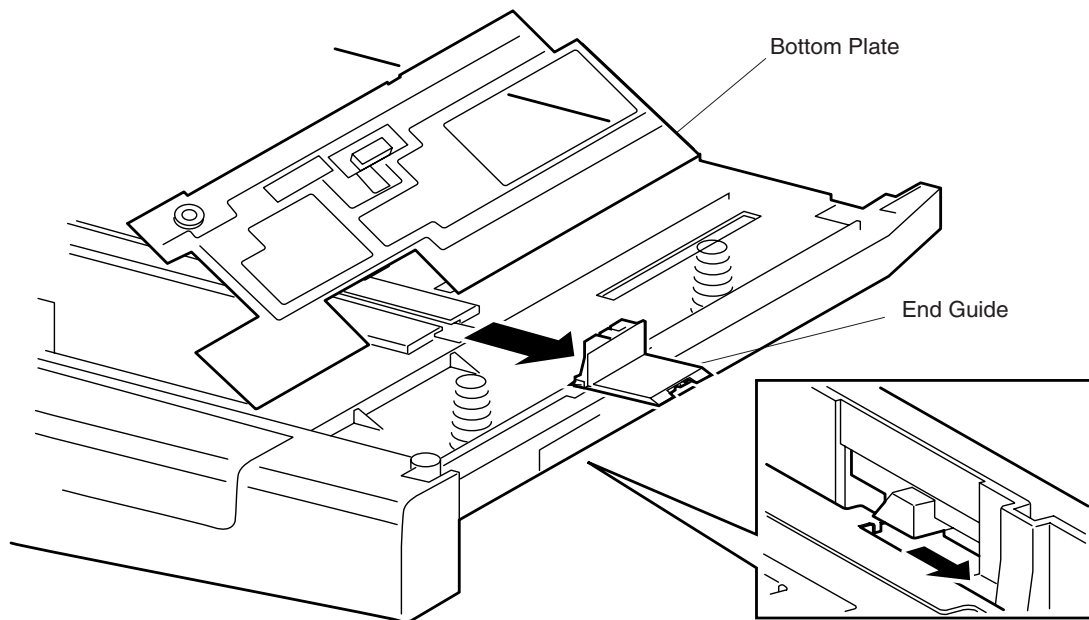
RRP 9.11 End Guide (PL2.2.16)

1. Raise the Bottom Plate.
2. Insert the End Guide knob into the end of the guide track.
3. Squeeze the End Guide handles and slide the End Guide onto the track.
4. Position the Tray so the bottom faces up.
5. Reinstall the Sector Gear (RRP 9.12).
6. Squeeze the End Guide handles and slide the End Guide back and forth to make sure it moves smoothly in the guide track and that the Sector Gear moves smoothly against the Tray Size Actuator.
7. Reinstall the Bottom Cover to the Tray.
8. Use five screws to secure the Bottom Cover to the Tray.
9. Reinstall Tray 1 into the printer.

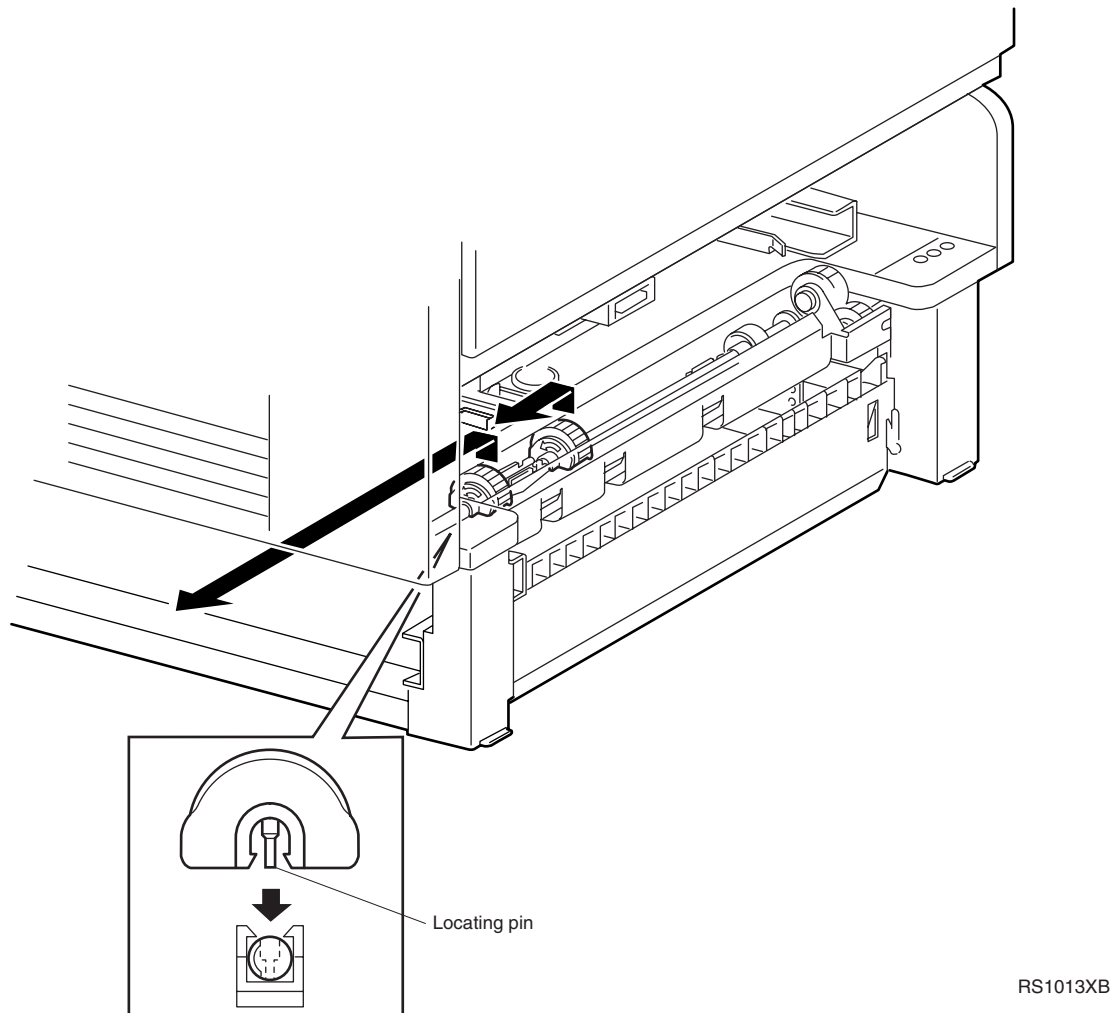
RRP 9.14 Feed Roll (PL3.1.3)

We recommend that you replace Feed Rolls as a set.

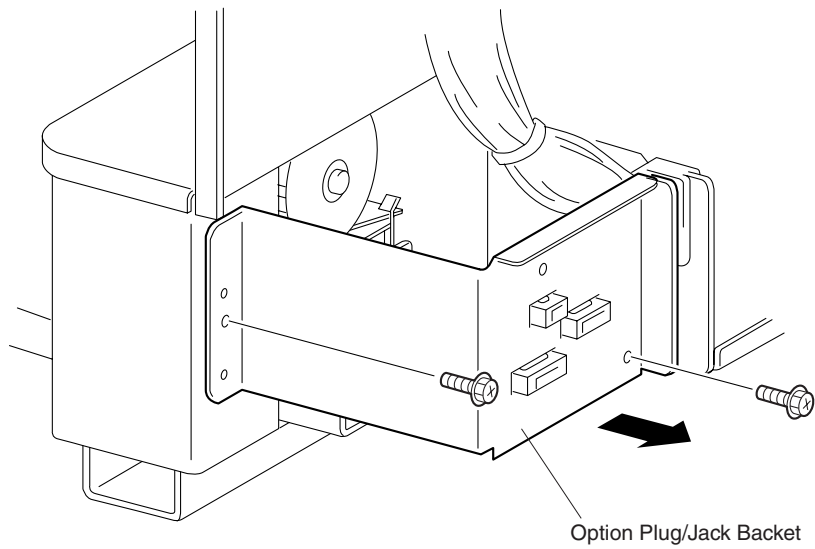
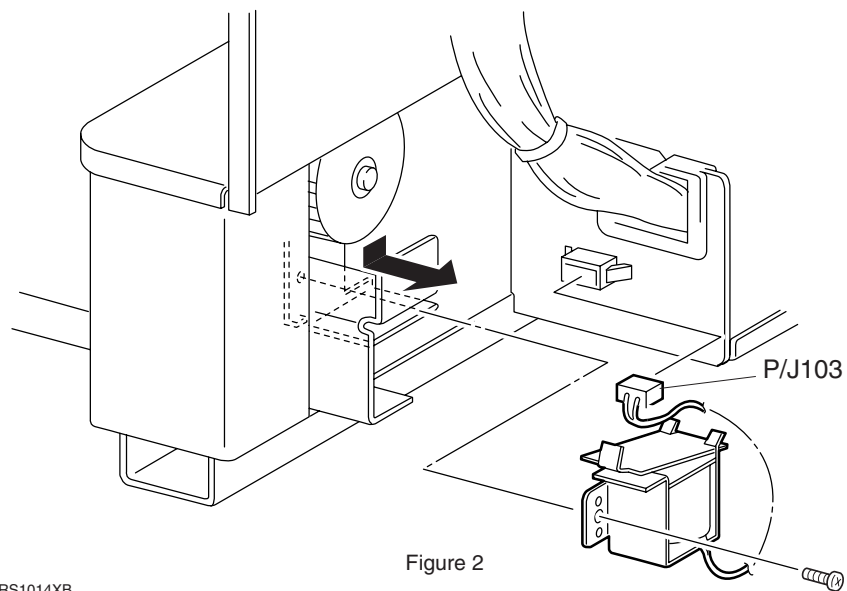
RRP 9.15 Feed Solenoid (PL3.1.9)

1. Push down on the Feed Solenoid arm so the Solenoid can clear the Feed Gear and reinstall the Solenoid onto the printer frame.
2. Use one screw to secure the Solenoid to the printer frame.
3. Reconnect P/J 103.
4. Reinstall the Option Plug/Jack Bracket onto the rear of the printer frame.
5. Use two screws to secure the Option Plug/Jack Bracket to the frame.
6. Reinstall the Turn Chute onto the printer frame, making sure you slide the bottom of the Chute under the Turn Roll Assembly so the four Turn Rolls fit through the opens in the Chute.
7. Use two screws to secure the Turn Chute to the printer frame.
8. Reinstall the Rear Cover (RRP 9.4).

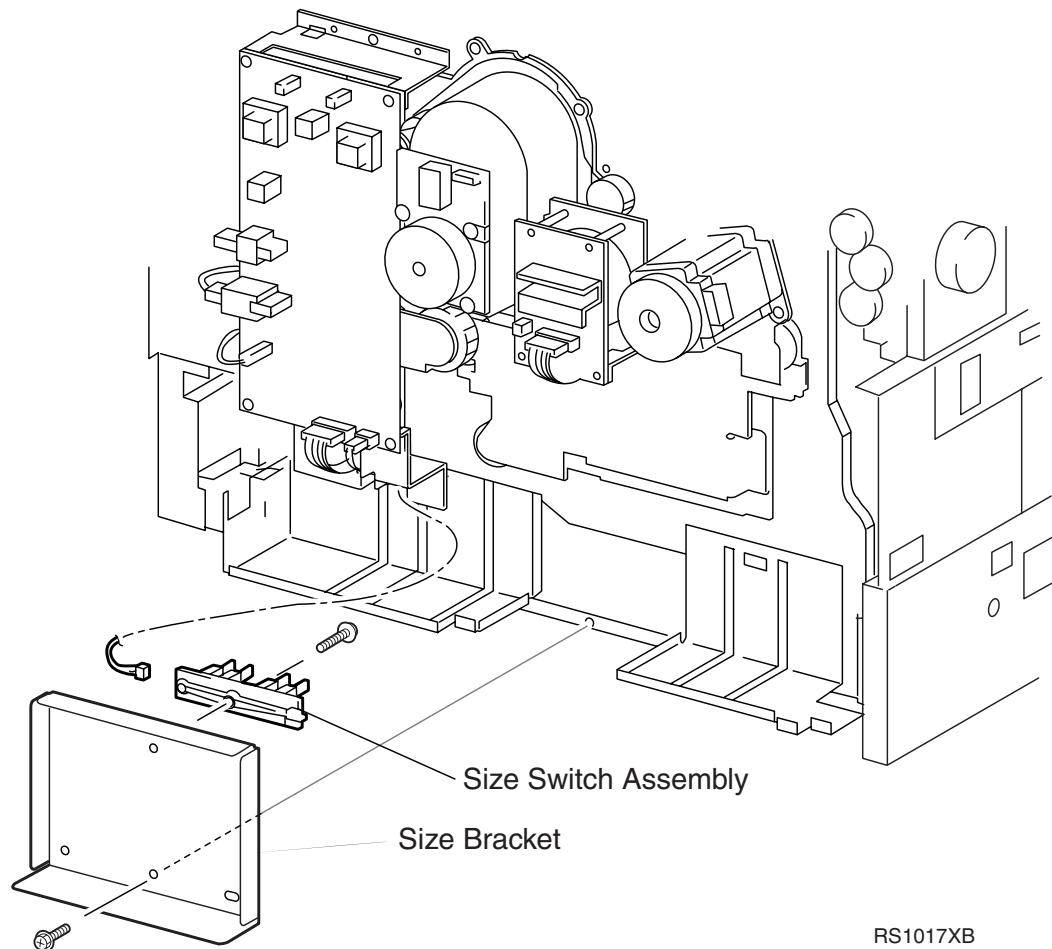
RRP 9.17 Size Switch Assembly (PL3.1.23)

1. Reinstall the Size Switch PWB onto the Size Bracket, making sure you line up the two plastic tabs at the back of the PWB with the two holes in the Bracket.
2. Use one screw to secure the PWB to the Size Bracket.
3. Reconnect P/J 102 to the Size Switch PWB.
4. Reinstall the Size Bracket onto the printer frame and use one screw to secure the Bracket.
5. Reinstall the LVPS (RRP 9.119).

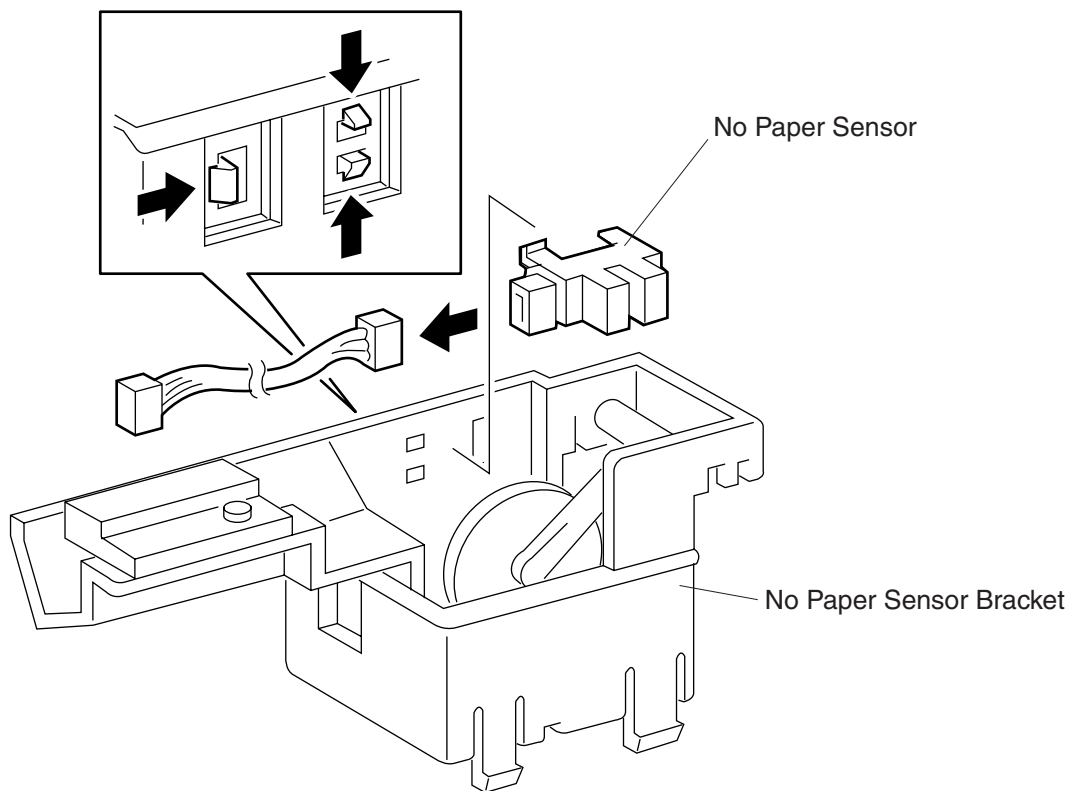
RRP 9.18 No Paper Sensor Assembly (PL3.1.30)

1. Position the Sensor so the P/J face the Low Paper Sensor.
2. Press the Sensor onto the Bracket until the Sensor latches snap into place.
3. Reconnect P/J 107 to the No Paper Sensor.
4. Reinstall the No Paper Bracket by inserting the latches of the Bracket up into the two cutouts in the printer frame.
5. Push in on the latches and push up on the Bracket until the latches lock into place.
6. Reinstall the Main Paper Handling Assembly (RRP 9.36).
7. Reinstall Tray 1 into the printer.

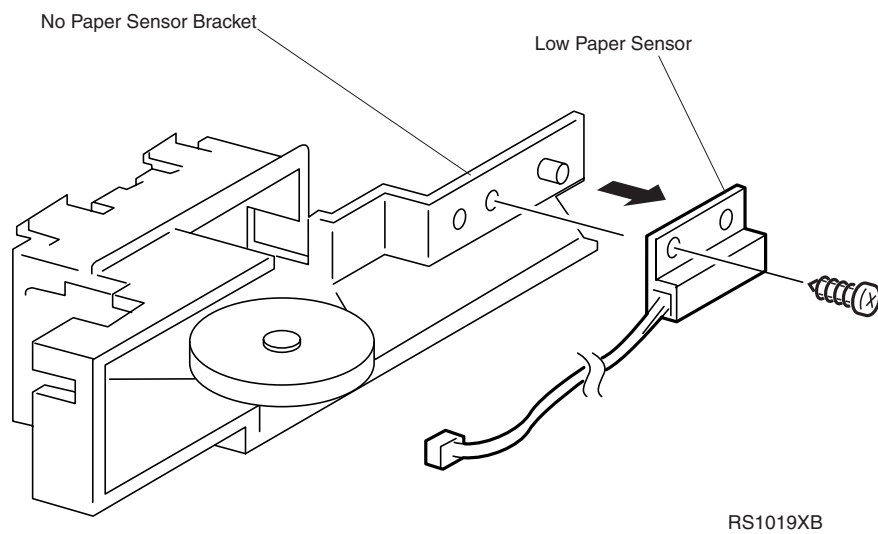
RRP 9.19 Low Paper Sensor (PL3.1.35)

1. Position the Low Paper Sensor against the No Paper Bracket so the Sensor wires are face the rear of the printer.
2. Reposition the Sensor so the two holes in the Sensor line up with the screw hole and positioning tab on the No Paper Bracket.
3. Use one screw to secure the Sensor to the Bracket.
4. Route the Sensor wire through the grommet hole in the frame, and reconnect the Sensor to P/J106.
5. Reinstall the No Paper Bracket by inserting the four latches of the Bracket up into the two cutouts in the printer frame.
6. Push in on the latches and push up on the Bracket until the latches lock into place.
7. Reinstall the Main Paper Handling Assembly (RRP 9.36).
8. Reinstall Tray 1 into the printer.

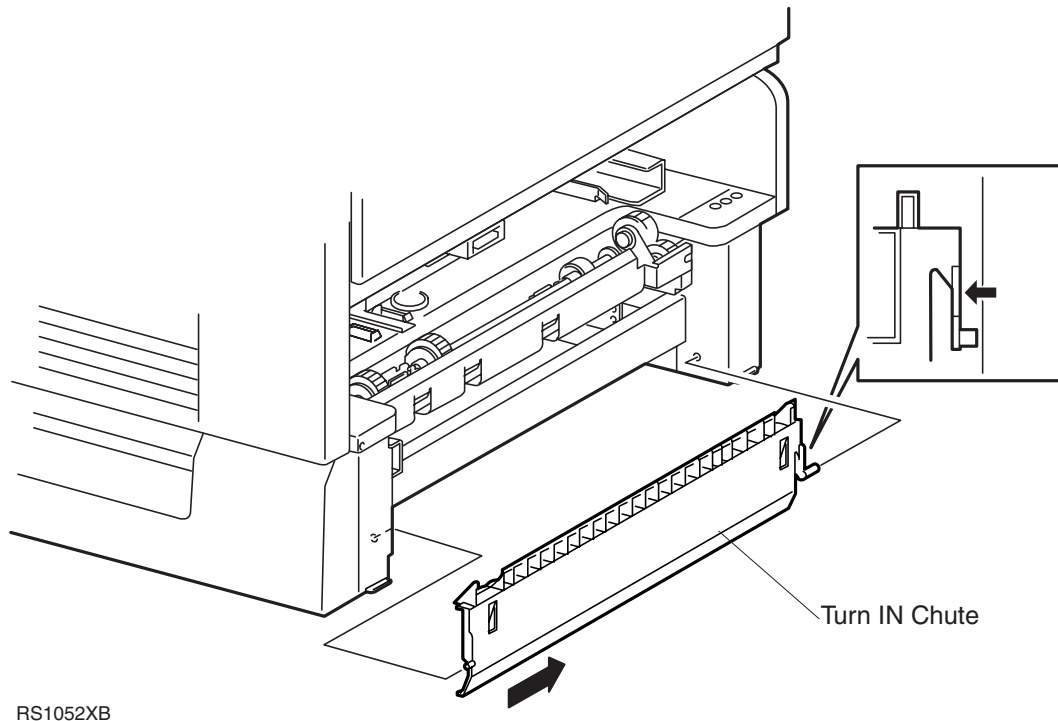
RRP 9.20 Turn IN Chute (PL3.1.18)

1. Insert the front pivot arm of the Turn IN Chute into the pivot hole in the front of the printer frame.
2. Press the rear pivot arm of the Turn IN Chute and insert the rear pivot arm into the pivot hole in the rear of the printer frame.
3. Reinstall the Main Paper Handling Assembly (RRP 9.36).

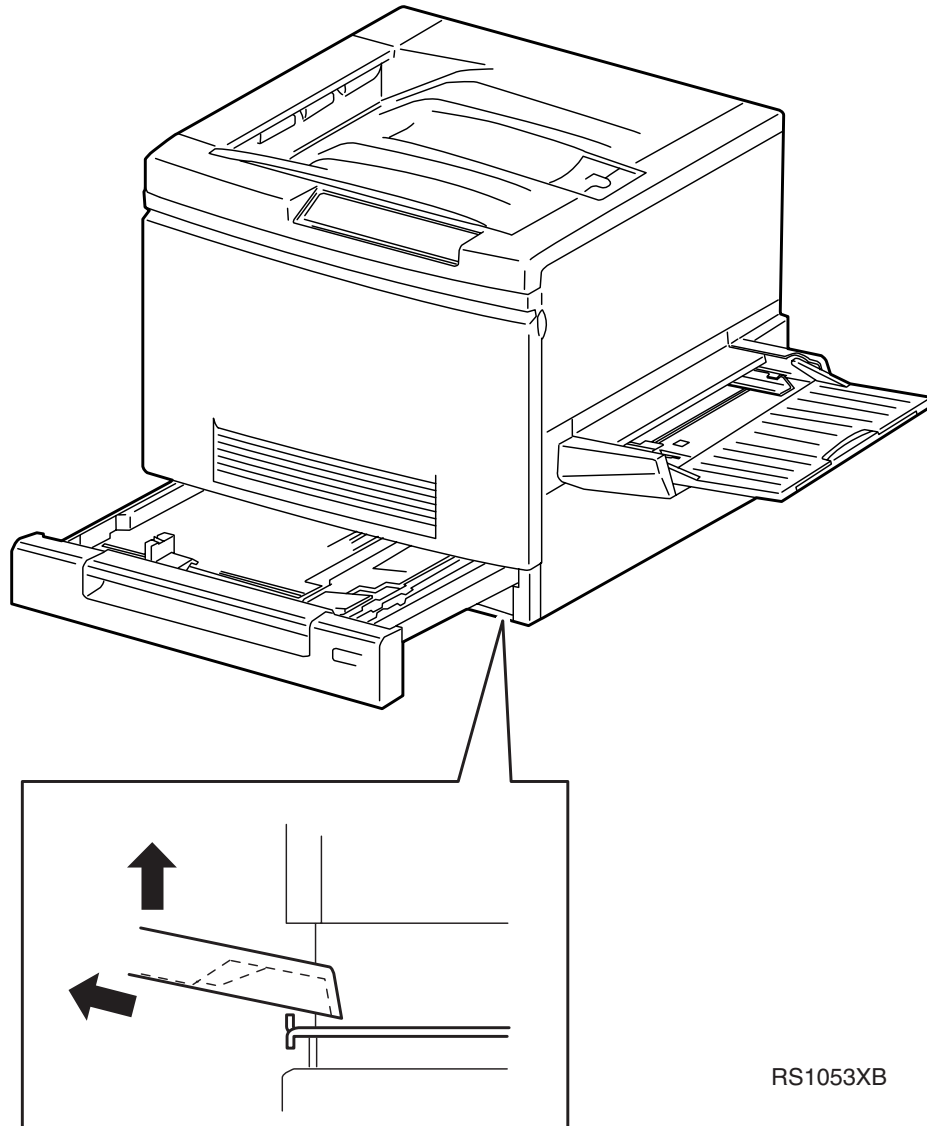
RRP 9.21 Universal Paper Tray (PL2.1.1)

1. Hold the Tray so the front is raised and insert the rear of the Tray into the printer.
2. Push the Tray in about an inch then lower the front so the Tray is horizontal and push the Tray all the way into the printer.

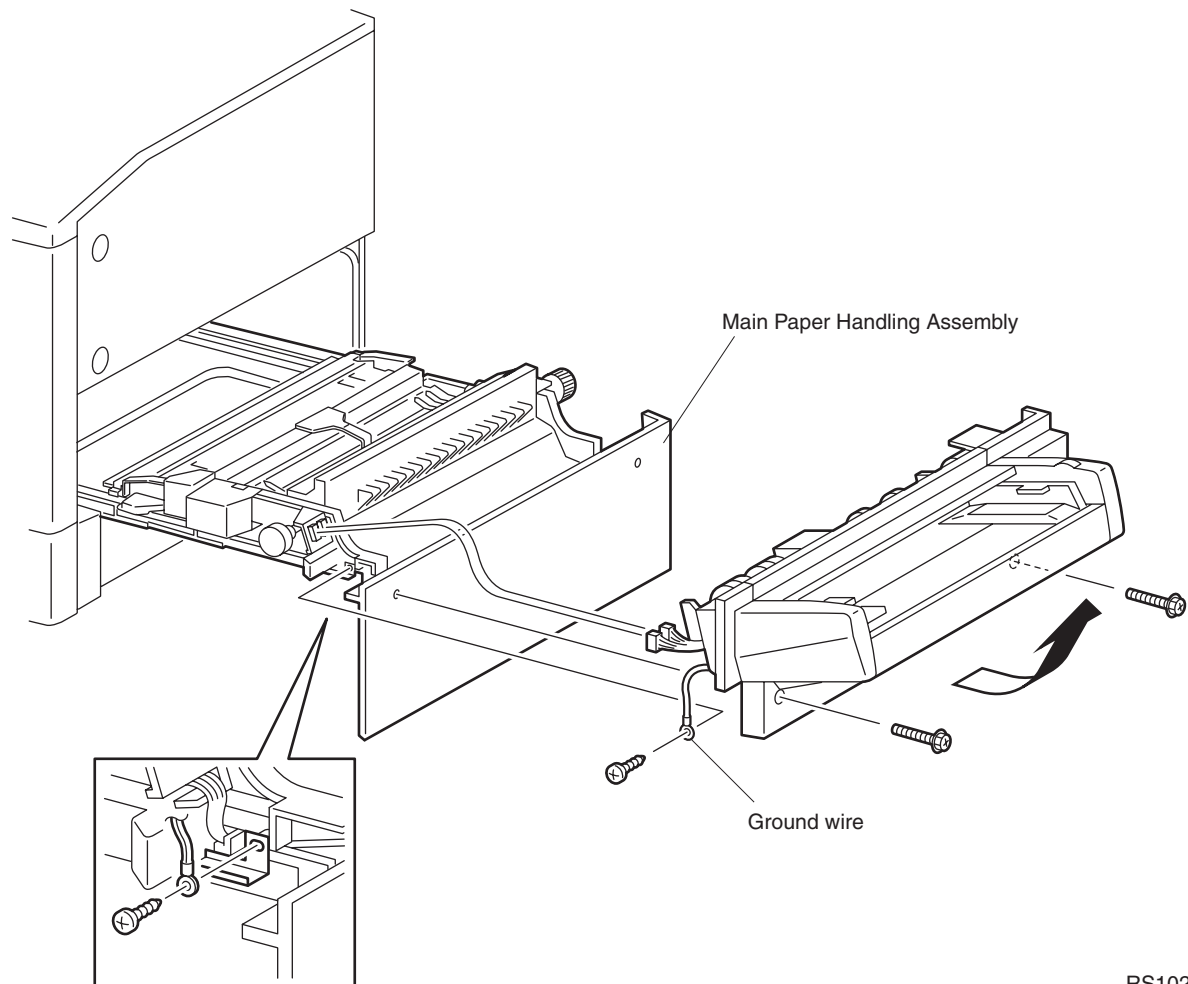
RRP 9.22 MSI Assembly (PL4.1.1)

1. Open the Main Paper Handling Assembly a few inches.
2. Reinstall the MSI Assembly onto the Main Paper Handling Assembly.
If installed correctly, the weight of the MSI Assembly should hold it in place on the Main Paper Handling Assembly.
3. If installed, reinstall the ground wire to the Main Paper Handling Assembly and use one screw to secure the wire to the Assembly.
4. Reconnect P/Js 91 and 92.
5. Use two screws to secure the MSI Assembly to the Main Paper Handling Assembly.
